Re: Carrier Corporation - Response to NYSDEC Requests for
Additional Information Dated August 12, 1996

**CARRIER CORPORATION'S RESPONSES TO
NYSDEC REQUESTS FOR ADDITIONAL INFORMATION
DATED AUGUST 12, 1996**

Thompson Road Plant

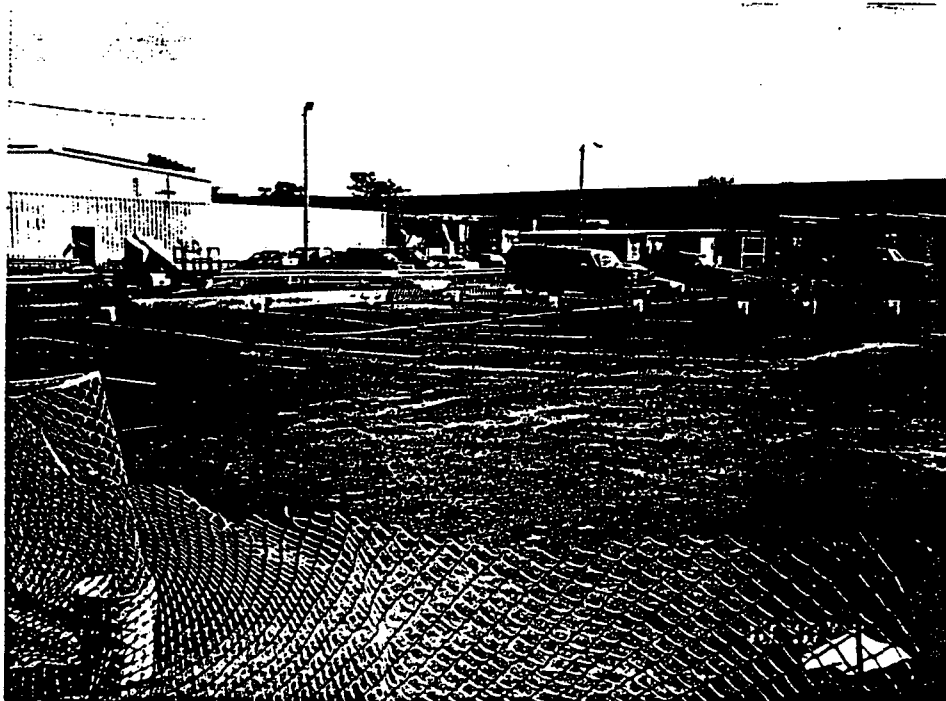
Photo No. 1-1: View, facing northeast, showing the location of former concrete and steel storage tanks, (SWMUs 1,2,3 & 4) located north of building TR-6.

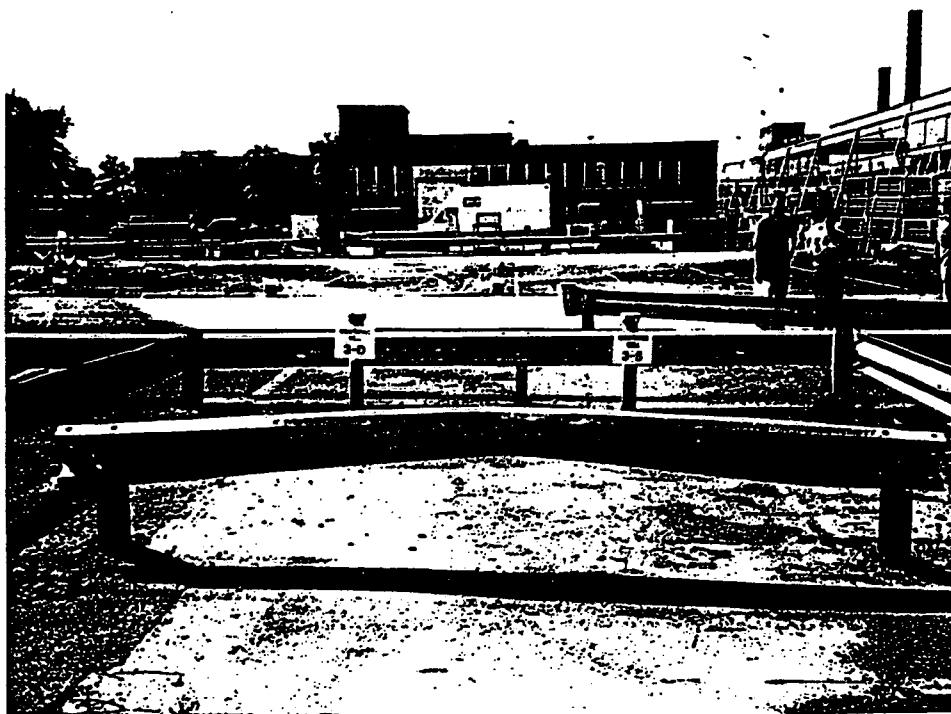
Photo No. 1-2: View, facing south, of groundwater monitoring wells in former concrete and steel storage tanks area located north of building TR-6.

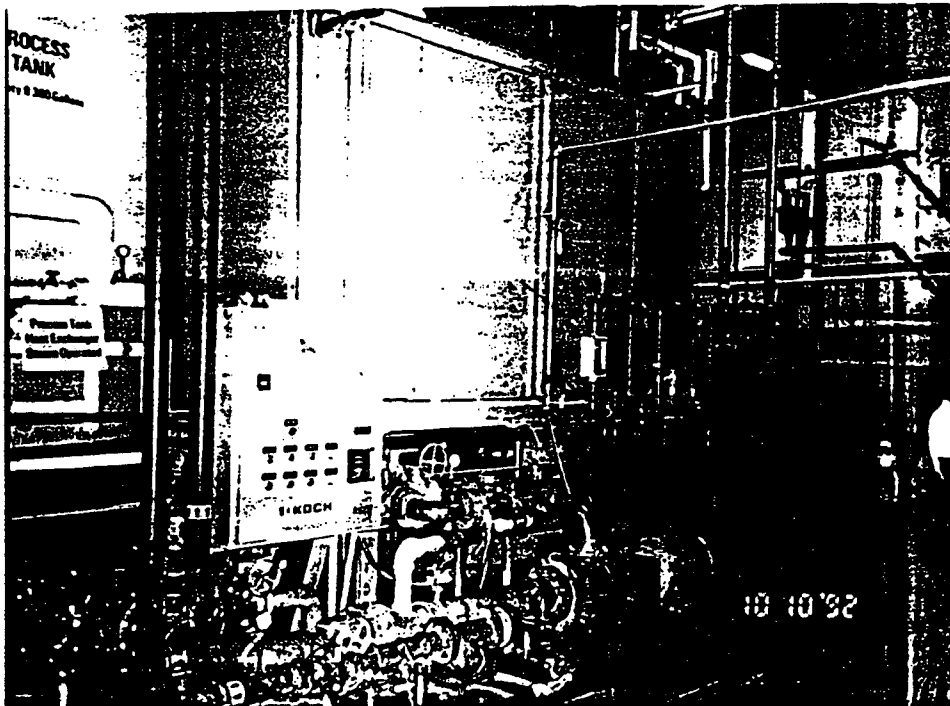
Photo No. 1-5: View, facing west, of the Ultrafiltration Unit (SWMU 15) located in building TR-3. The unit is used to filter cooling fluid.

1058 R1 P5 - Photo facing West of Ultrafiltration Unit.
- used to filter cooling fluid
- capacity 10,000 gal/day

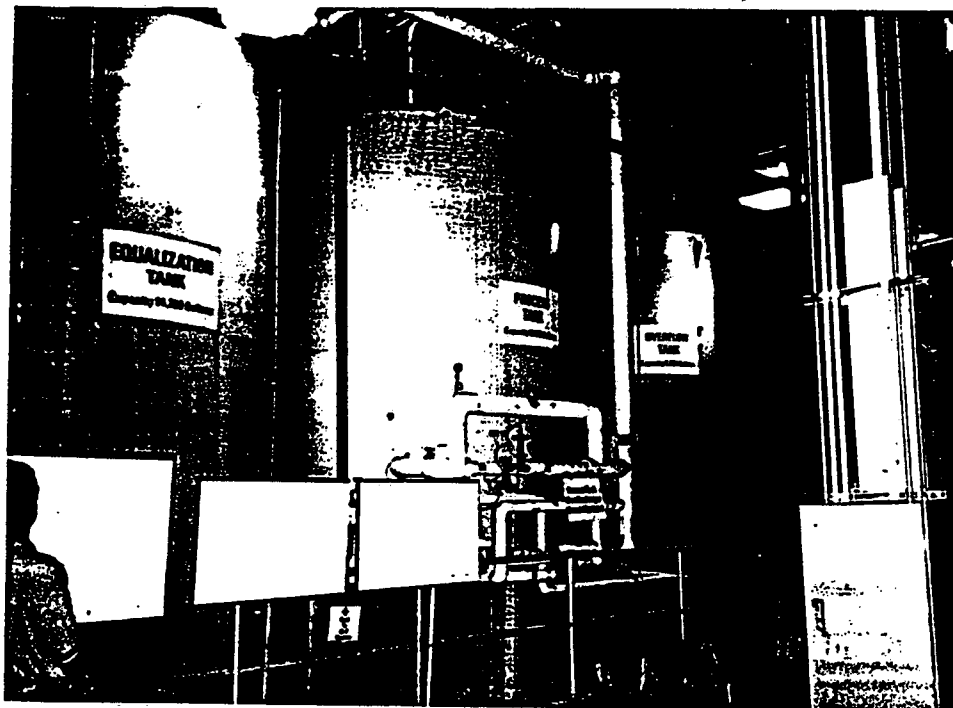
Photo No. 1-6: View, facing north, of Equalization Tank, Process Tank and Overflow Tank (SWMU 15) located in building TR-3.

1102 R1 P6 - Photo facing North of equalization tank, process tank, overflow tank and Used oil tank. - Concrete floor -

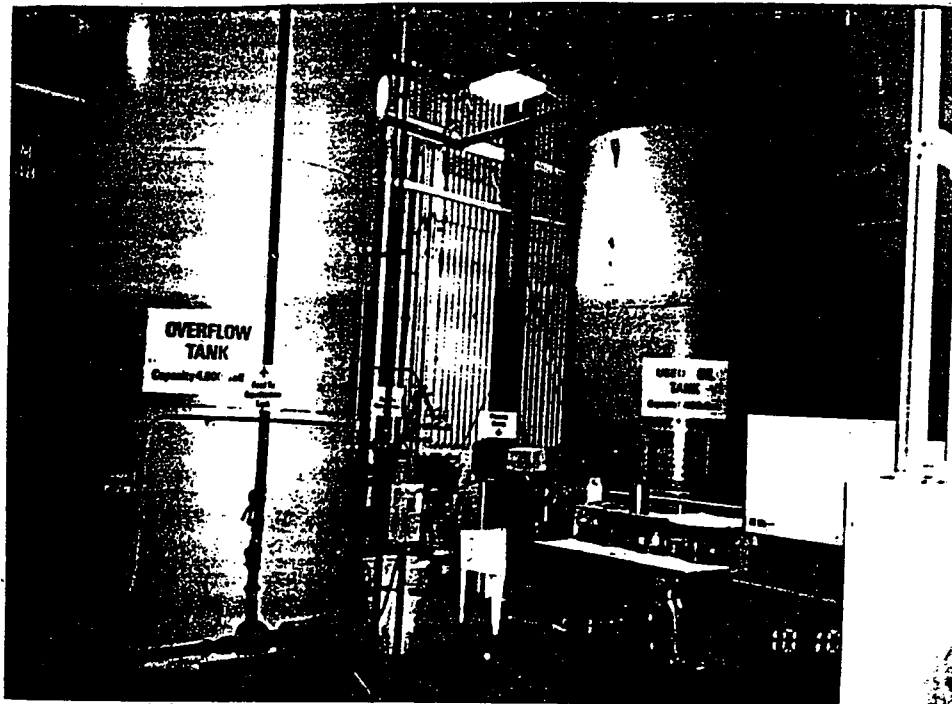
Photo No. 1-7: View, facing northwest, of Overflow Tank and Used Oil Tank (SWMU 15) located in building TR-3.

1103 R1 P7 - Photo facing NW of (same as above) overflow & used oil tanks

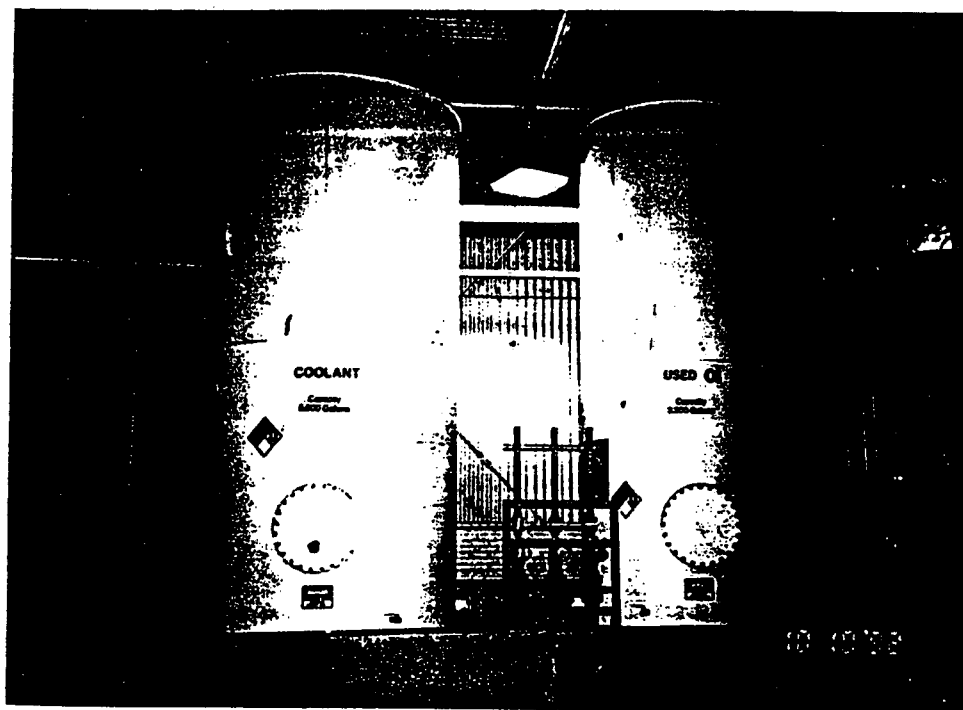
Photo No. 1-8: View, facing southwest of two Interim Storage Tanks (SWMU 17) located in building TR-3. These tanks are used for the collection of used oil and coolant.

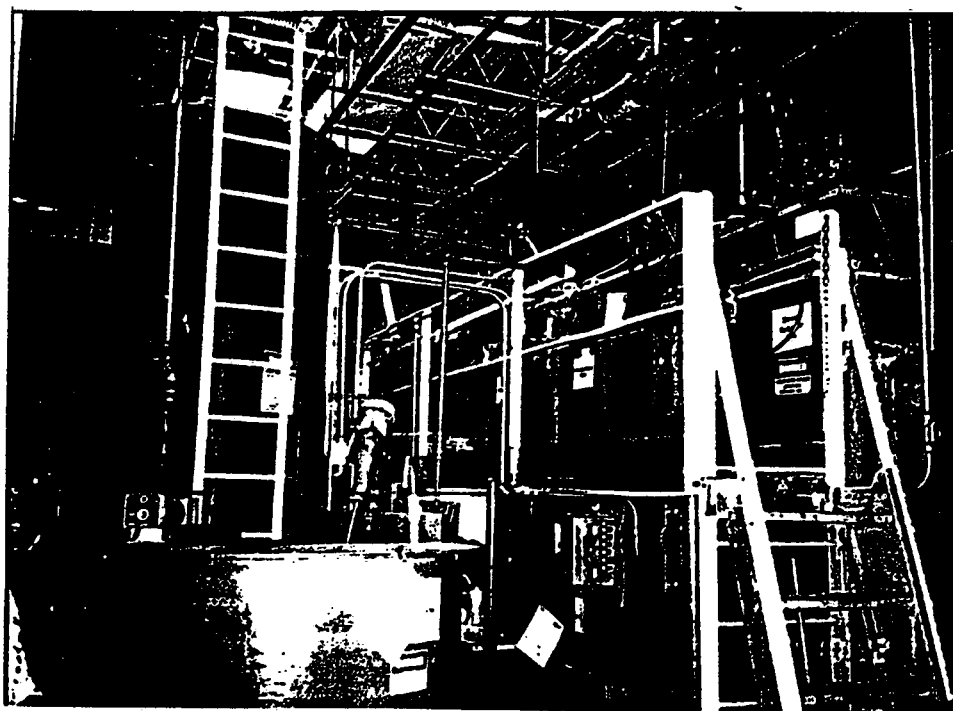
Photo No. 1-10: View, facing northwest, of Chromium Reduction Tank, pH Reduction tank, 'Flop' Tank and Secondary Settling Tank (SWMU 16) located in building TR-20.

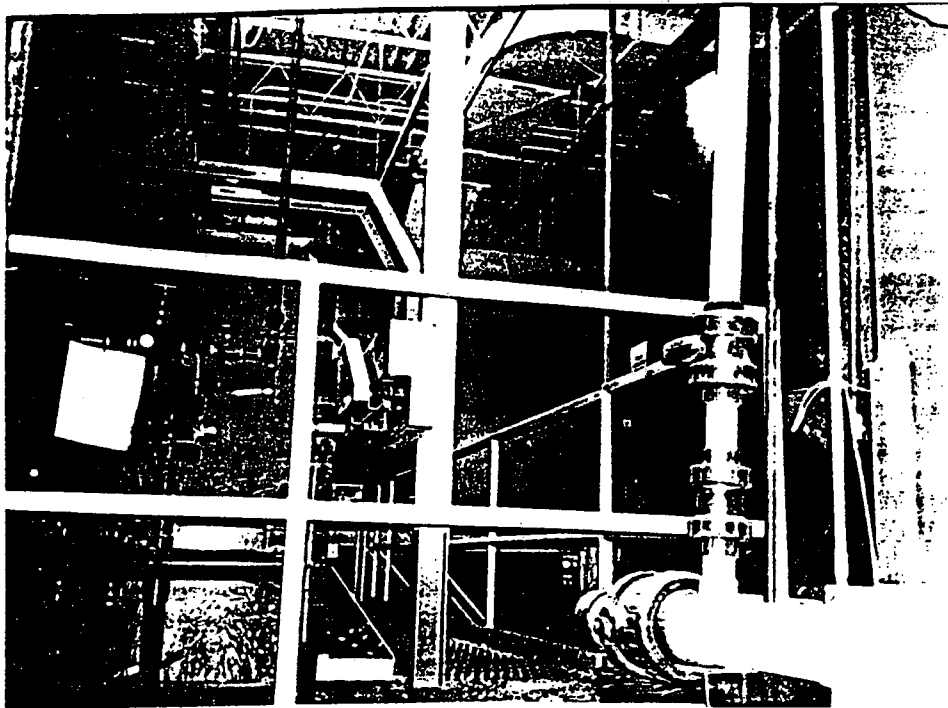
Photo No. 1-11: View, facing north, of Filter Press and Primary Settling Tank (SWMU 16) located in building TR-20.

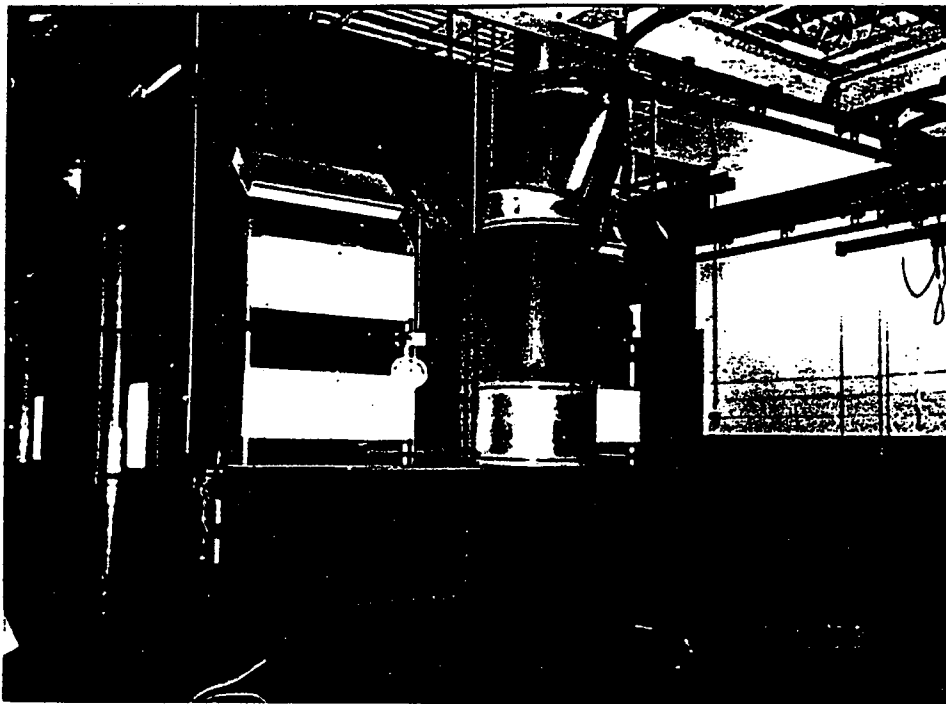
Photo No. 1-12: View, facing north, of Dry Filter Paint Unit and Filter Booth (SWMU 14) located in building TR-20.

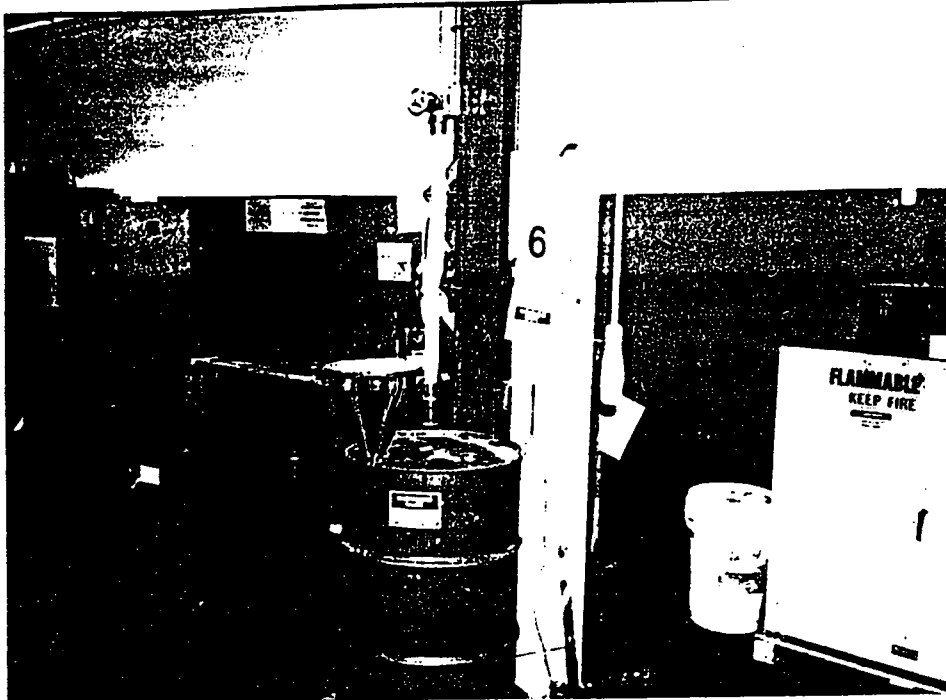
Photo No. 1-13: View, facing south, of Satellite Accumulation Area (SWMU 12) showing a 55-gallon drum containing paint solvents and thinners. Note proper labels and concrete containment. This unit is located in building TR-20.

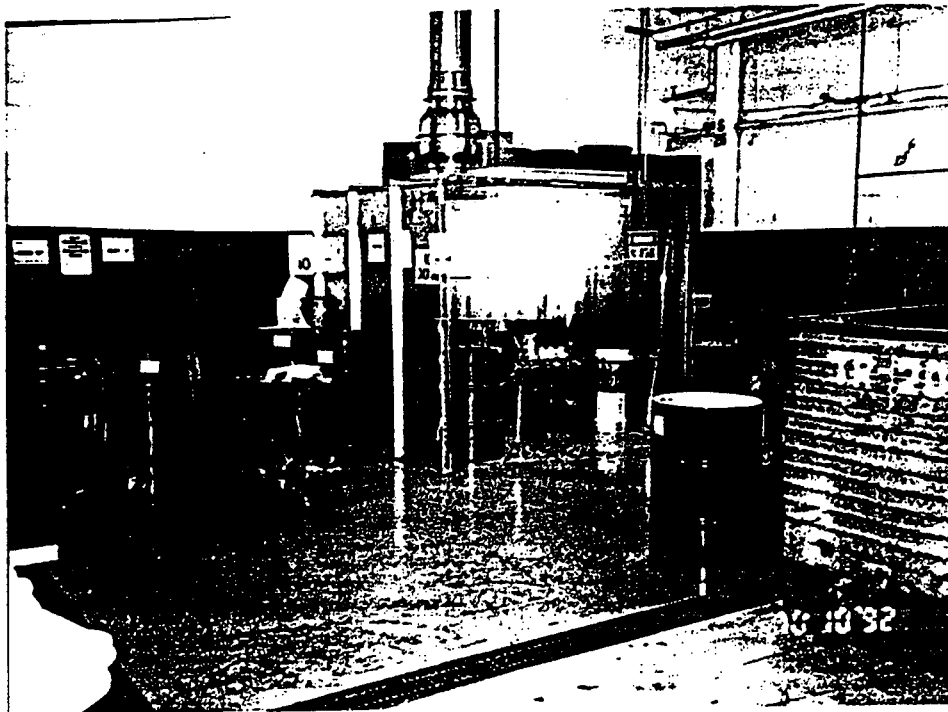
Photo No. 1-15: View, facing east, of 'Drop Zone' Satellite Accumulation Area (SWMU 12) located in building TR-20. This unit is used to recover liquid wastes and 'paint can heels'. Note concrete containment and blind sump drain.

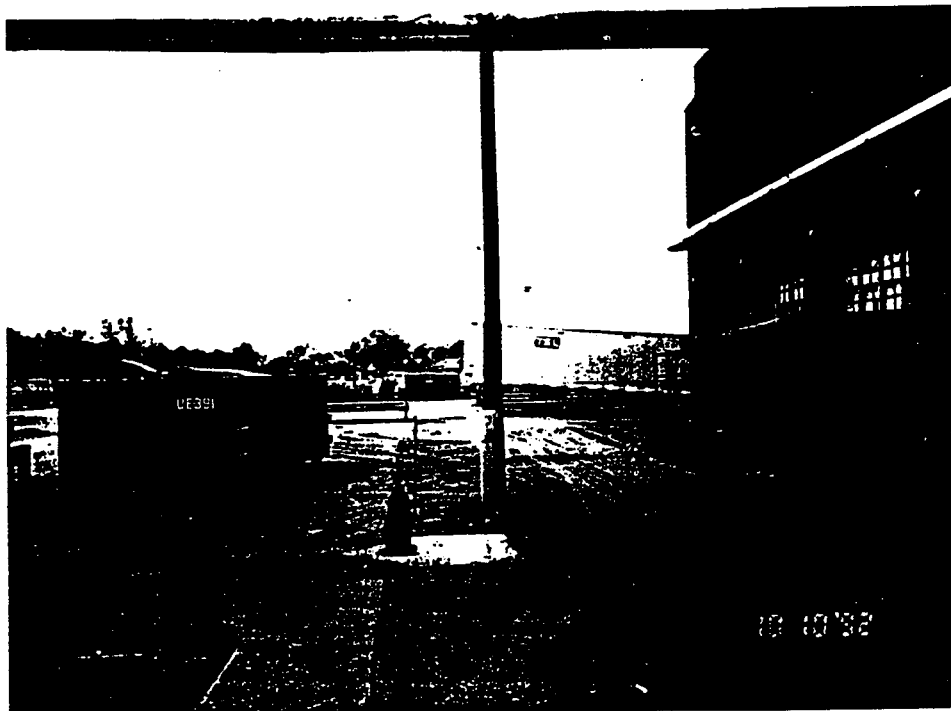
This unit has been included as a SWMU because it was open and outdoors and the possibility existed that exposed metals could rust and decompose and runoff could carry metals into the soil and groundwater. During the VSI, the pavement was found to be cracked in some places. However, no stains or other indication of runoff from wastes stored here were observed during the VSI. Therefore, the potential for this unit to release is minimal.

Photo No. 1-16: View, facing southwest, of Scrap Metal Storage Area (SWMU 11). This unit is located outside adjacent to building TR-5.

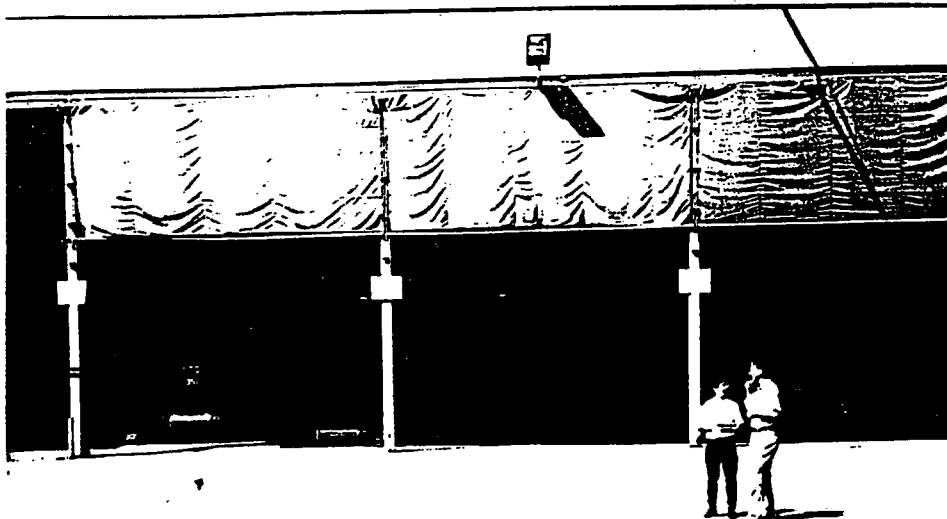
Photo No. 1-17: View, facing west, of TR-5 Shed, which houses nonhazardous paint debris, aluminum chips, Speedy Dry and oil debris.

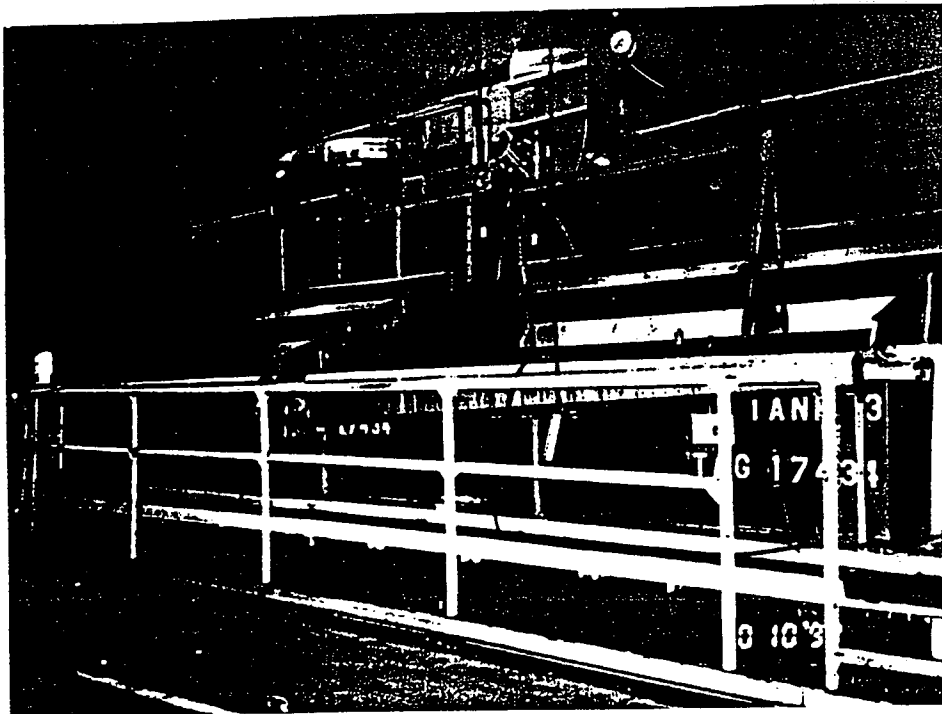
Photo No. 1-19: View, facing northwest, of Acid/Alkaline Tanks #3 and #4 (SWMU 10) used in metal cleaning process. These are steel tanks with a capacity of 6000 gal/each and are located in building TR-1 adjacent to Acid/Alkaline Tanks #1 and #2.

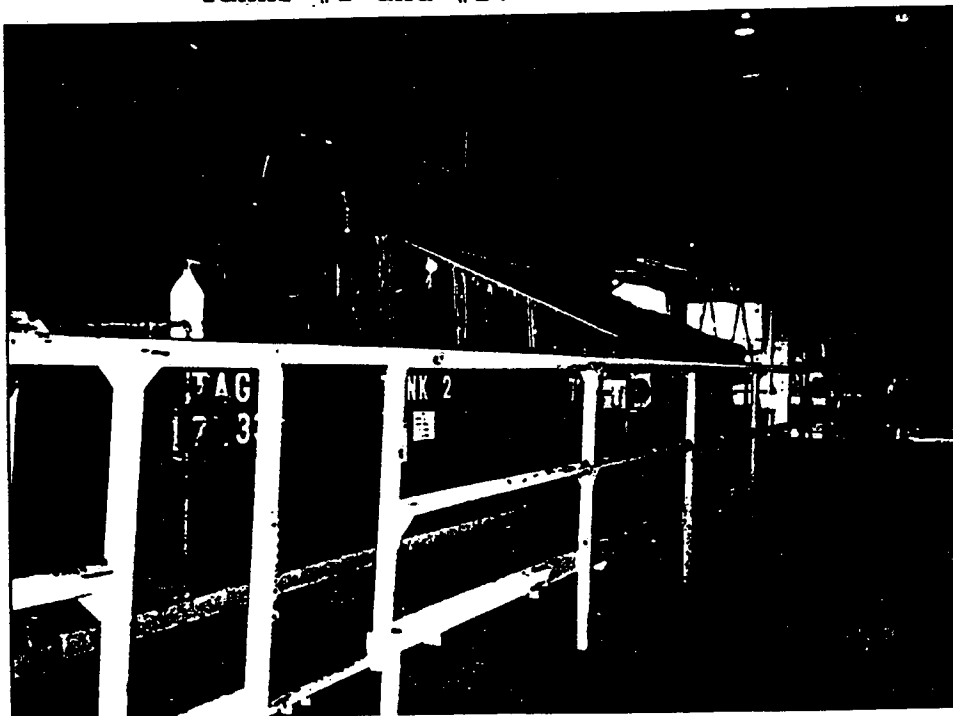
Photo No. 1-20: View, facing north of Acid/Alkaline Tanks #1 and #2 (SWMU 10) used in the metal cleaning process. These are steel tanks with the capacity of 6000 gal/each and are located in building TR-1. Note concrete containment.

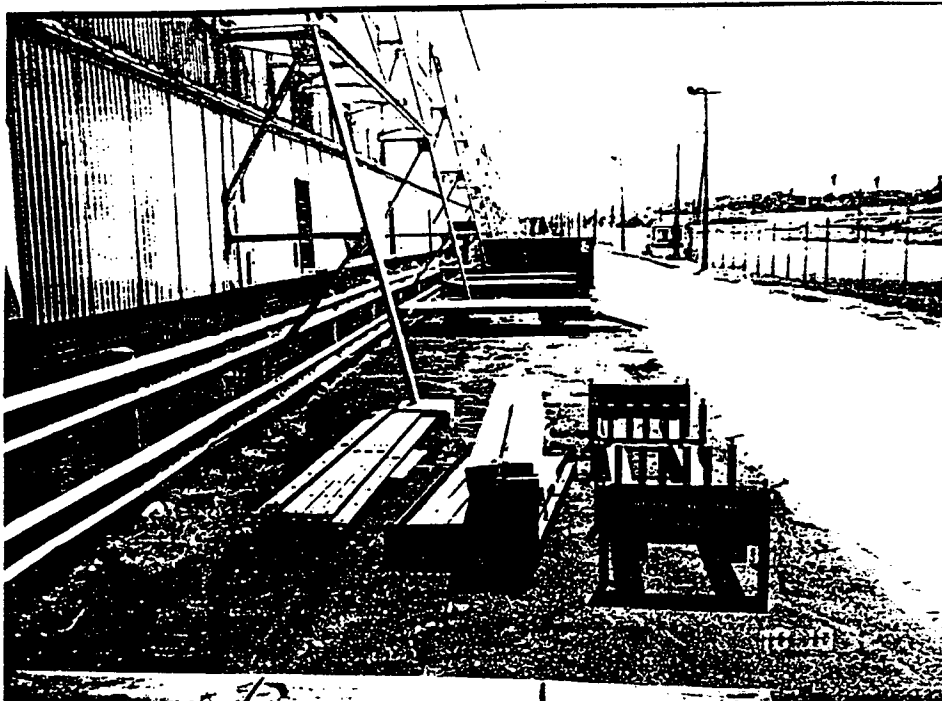
Because the units were unlined in-ground concrete tanks, one of which (SWMU 5) managed potentially corrosive hazardous waste, and no confirmatory sampling was conducted, these units had a moderate potential to release.

Photo No. 1-21: View, facing south, of former storage tank area (SWMUs 5 & 6). Two 8000 gal. in-ground concrete tanks were removed from here in the late 1970's. These tanks were used to store acid/alkaline solution and are located adjacent to the east side of building TR-1.

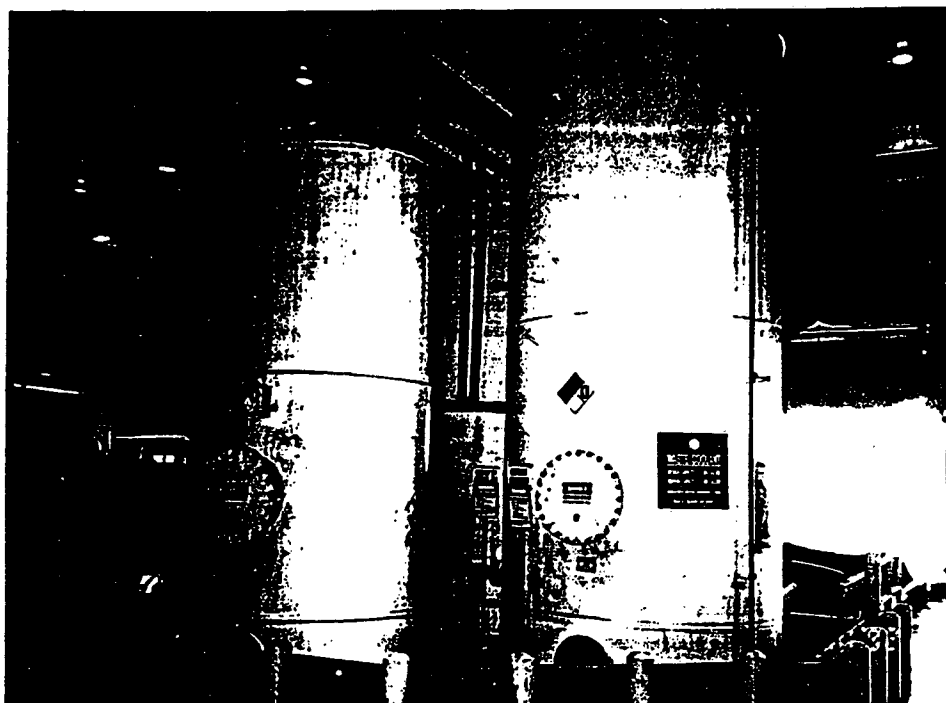
Photo No. 1-22: View, facing south, of Bulk Tank Area (SWMU 9) used to store waste oil, coolant and acid/alkaline solutions. These tanks are located in building TR-1. Note concrete containment wall around tanks.

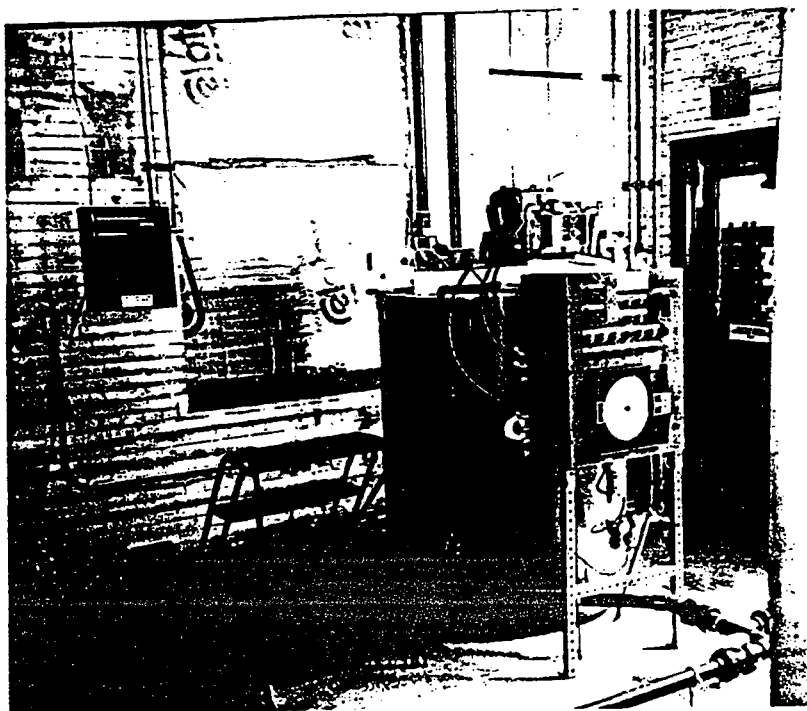
Photo No. 1-23: View, facing east, of fiberglass mixing tank which mixes blowdown with sulfuric acid for neutralization. The tank has a capacity of 500 gal. and is located in building TR-13.

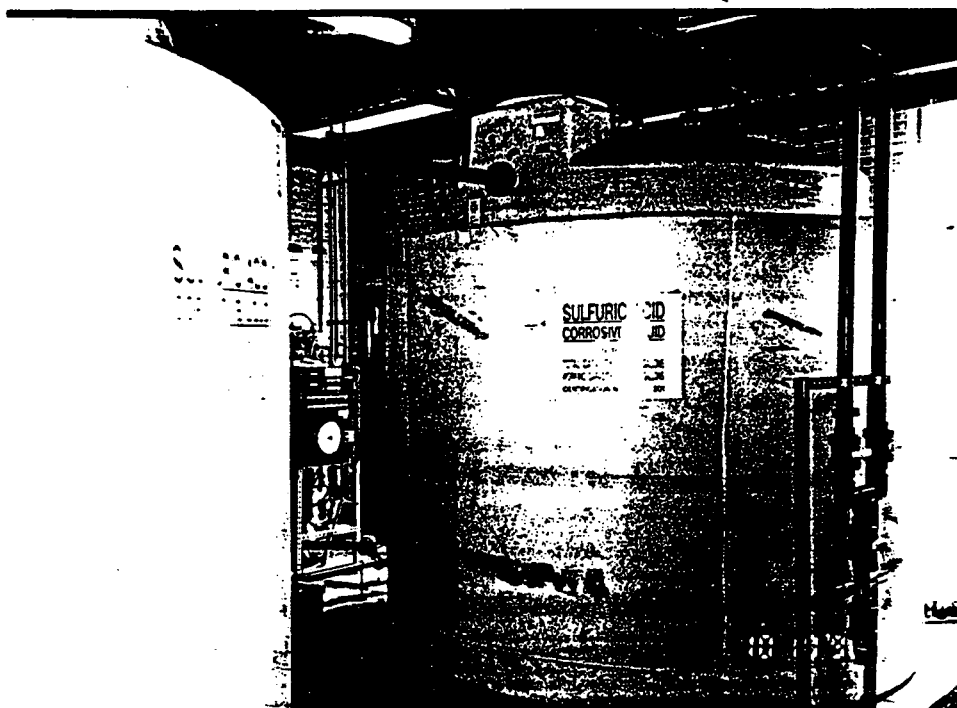
Photo No. 1-24: View, facing southeast, of two fiberglass 3000 gal. tanks containing sulfuric acid. These tanks are located in building TR-13.

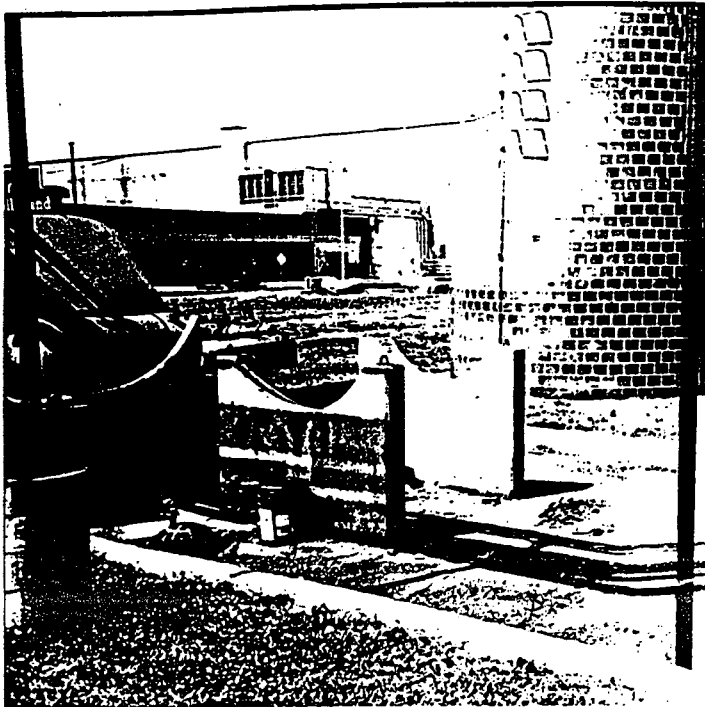
During the VSI, the location of the former unit was observed to be somewhat overgrown but exhibited no evidence of a release. The concrete saddle and bermed area were intact. Therefore, the past and present potential for release from this unit is minimal.

Photo No. 1-25: View, facing southeast, of former above ground waste oil tank area (SWMU 7) located adjacent to building TR-13. Tanks were taken out of service in the late 1970's. Note concrete containment.

1351 R1 P25 Photo facing SE of former above ground waste oil tank area - taken out of service in Late 1970's. Concrete berm containment - Currently somewhat stained but intact.

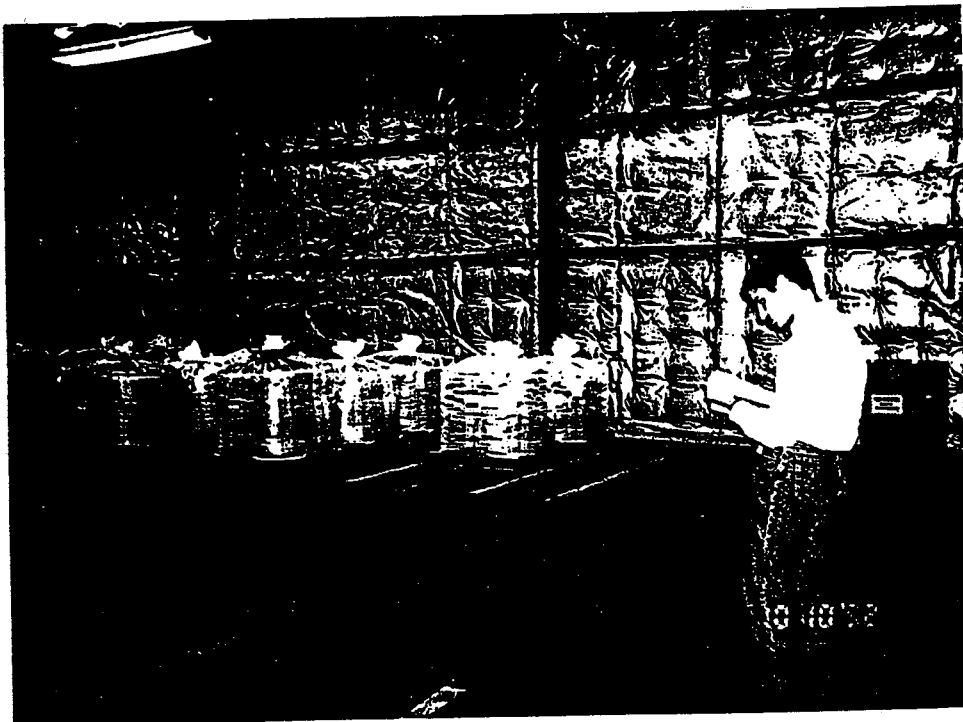
During the VSI this unit appeared to be well managed and no signs of spills or cracking in the concrete were observed. In general, NYSDEC has approved of the operations of this unit in its annual inspections. As a result, this unit poses minimal potential to release.

Photo No. 2-1: View, facing northeast, of Less-Than-90 Day Storage Area (SWMU 8) located in building TR-23. Storage area is used to store all hazardous wastes on site. Note concrete containment with 3"-4" berm and blind sump.
